Home Inspection Report

123 45th St.
Anytown, NJ 00000

Prepared for: John and Mary Homebuyer

Prepared by: AtlantiCape Inspections, LLC
7809 Wellington Ave.
Margate, NJ 08402

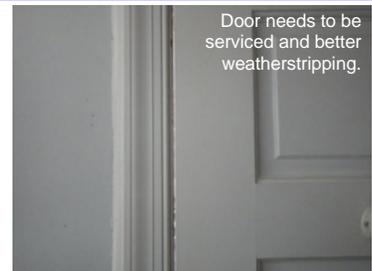
11. *Defective* Door(s): *Wood hinged The front door is jammed in its frame requiring considerable effort to open and close. Additionally, when closed, there are gaps between the door and frame indicating poor weatherstripping. I recommend having the door shaved or otherwise serviced, to restore proper function, and the addition of weatherstripping to eliminate excessive air leakage.*

1. Front porch entry Decks and Porches Door(s): *Wood hinged The front door is jammed in its frame requiring considerable effort to open and close. Additionally, when closed, there are gaps between the door and frame indicating poor weatherstripping. I recommend having the door shaved or otherwise serviced, to restore proper function, and the addition of weatherstripping to eliminate excessive air leakage.*

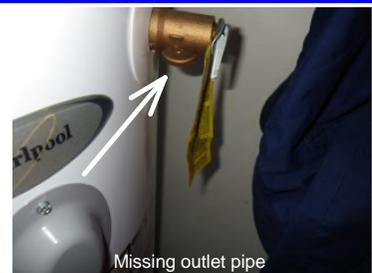
7. *Acceptable* Water Heater Operation: *Functional at time of inspection*
8. Manufacturer: *Whirlpool*
9. Model Number: *EEH50RD045V* Serial Number: *0518114060*
10. Type: *Electric* Gallon Capacity: *50 Gal.*
11. *Acceptable* BTUH Capacity: *4,500 watts*
12. Year Manufactured: *2005* Area Served: *Living unit*
13. *Defective* TPRV and Drain Tube: *Pipe The temperature-pressure relief (TPR) valve was missing its required outlet pipe. I recommend installing the pipe at the exit to the TPR valve and terminating it within 6" of the floor, per industry standard practice.*

2. Front bedroom closet Water Heater TPRV and Drain Tube: *Pipe The temperature-pressure relief (TPR) valve was missing its required outlet pipe. I recommend installing the pipe at the exit to the TPR valve and terminating it within 6" of the floor, per industry standard practice.*

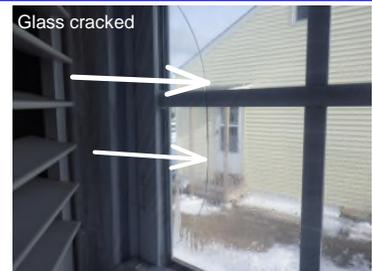
- 6. *Defective* Windows: Vinyl double hung *The insulated glass top sash had a broken glass pane. I recommend having the insulated glass section replaced, to restore proper function.*

3. Rear Kitchen Windows: *Vinyl double hung The insulated glass top sash had a broken glass pane. I recommend having the insulated glass section replaced, to restore proper function.*

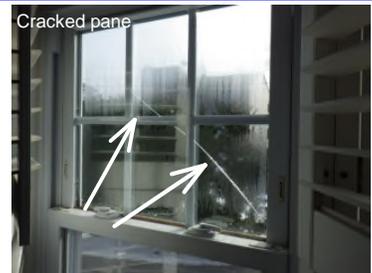
- 16. *Defective* Windows: *Vinyl double hung* *The insulated glass top sash of the left window had a broken glass pane. I recommend having the insulated glass section replaced, to restore proper function.*
- 17. *Not Present* Lights: *None*
- 18. *Not Inspected* Outlets: *None tested* *All of the outlets were blocked by furniture or the tenants possessions, so I could not test any.*
- 19. *Acceptable* Ceiling Fan: *Surface mounted*
- 20. *Not Inspected* Closet: *Single, hinged door* *The closet was totally filled with clothing, so I was not able to visually inspect it as a result.*
- 21. *Acceptable* HVAC Source: *Radiant heat*

5. Rear Bedroom Windows: *Vinyl double hung The insulated glass top sash of the left window had a broken glass pane. I recommend having the insulated glass section replaced, to restore proper function.*

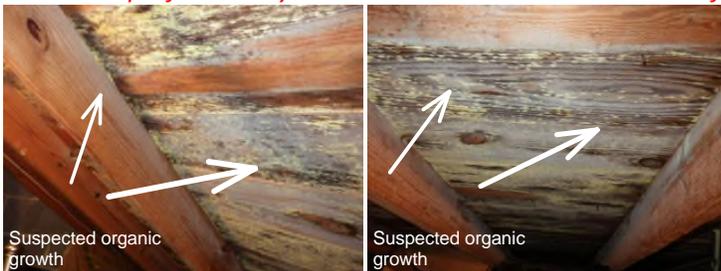
- 5. *Defective* Ventilation: *Attic fan - thermostatically controlled* *Ventilation is inadequate in this attic. A single attic fan is insufficient for this task. The existence of suspected organic growth on the roof sheathing (green patches mentioned earlier in this section) would seem to confirm poor ventilation conditions. So, I recommend having additional venting added, and any material determined to be mold by a mold inspector should be professionally remediated once the ventilation deficiency is corrected.*

6. Main Attic Ventilation: *Attic fan - thermostatically controlled Ventilation is inadequate in this attic. A single attic fan is insufficient for this task. The existence of suspected organic growth on the roof sheathing (green patches mentioned earlier in this section) would seem to confirm poor ventilation conditions. So, I recommend having additional venting added, and any material determined to be mold by a mold inspector should be professionally remediated once the ventilation deficiency is corrected.*

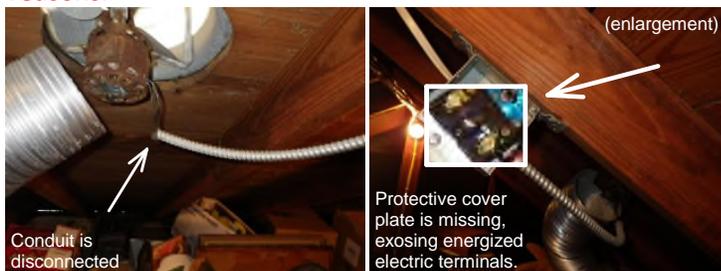
- 8. *Defective* Attic Fan: *Direct drive The attic fan did not function on a wall switch or thermostatic control, and the blade was stiff when I tried to spin it. Additionally, the conduit protecting the electric wiring was detached from the fan housing, exposing the insulated wires, and the wiring box had no protective cover. I recommend having the fan serviced or replaced, and the wiring issues addressed by an electrician, for safety reasons.*
- 9. *Acceptable* Wiring/Lighting: *120 VAC lighting circuit*

7. Main Attic Attic Fan: *Direct drive The attic fan did not function on a wall switch or thermostatic control, and the blade was stiff when I tried to spin it. Additionally, the conduit protecting the electric wiring was detached from the fan housing, exposing the insulated wires, and the wiring box had no protective cover. I recommend having the fan serviced or replaced, and the wiring issues addressed by an electrician, for safety reasons.*

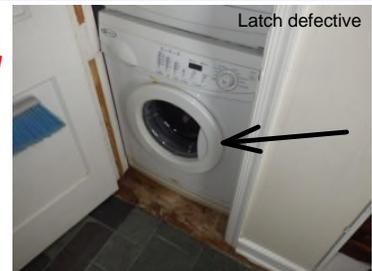
5. *Not Inspected* Outlets: *120 VAC Blocked*
6. *Defective* Washer: *Maytag The front-loading washer had a defective latch and so the washer would not start. I recommend having the appliance serviced, to restore proper function.*

- Closet by entrance Laundry Room/Area Washer: Maytag *The front-loading washer had a defective latch and so the washer would not start. I recommend having the appliance serviced, to restore proper function.*

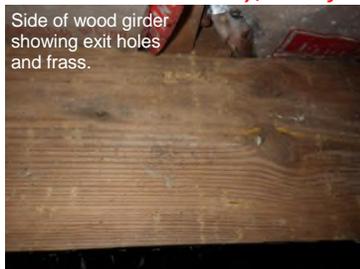
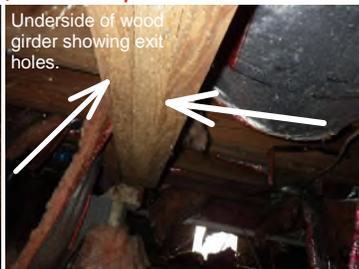
5. *Defective* Beams: *Wood girder The main girder exhibited powder post beetle activity. Powder post beetles are wood-destroying insects. I found numerous exit holes and frass (wood dust created from beetle activity clinging to the side of the wood) throughout the girder, enough to convince me that repairs are needed. Normally, visible frass would suggest ongoing beetle activity, however I was informed that the home was treated in 2004. Nonetheless, I recommend having a pest inspector evaluate this further to determine if there is recent activity, and if so, what steps are needed to kill off the insects.*

- Beams: Wood girder *The main girder exhibited powder post beetle activity. Powder post beetles are wood-destroying insects. I found numerous exit holes and frass (wood dust created from beetle activity clinging to the side of the wood) throughout the girder, enough to convince me that repairs are needed. Normally, visible frass would suggest ongoing beetle activity, however I was informed that the home was treated in 2004. Nonetheless, I recommend having a pest inspector evaluate this further to determine if there is recent activity, and if so, what steps are needed to kill off the insects.*

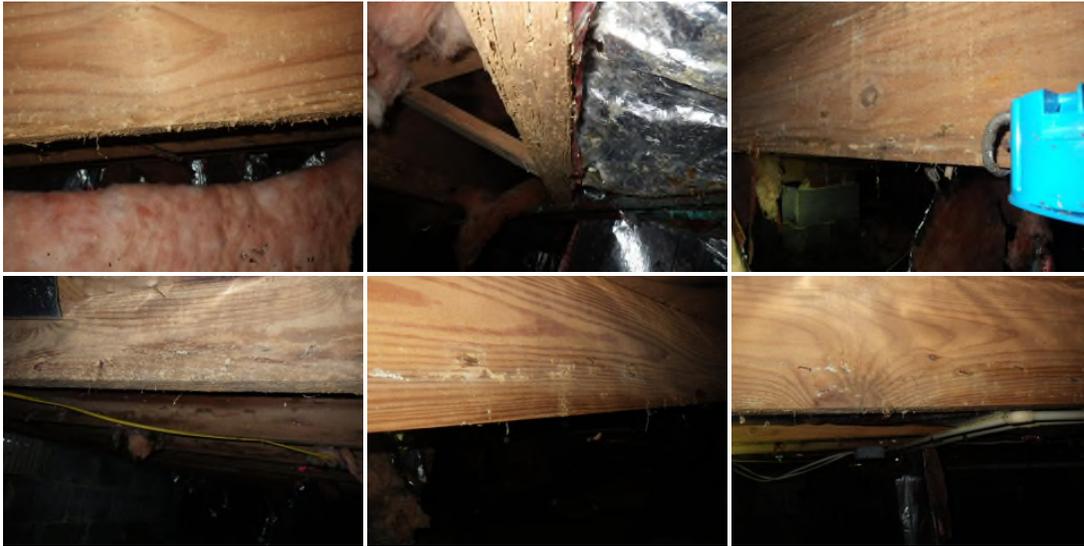
6. *Acceptable* Bearing Walls: *Block*
7. *Defective* Floor Joists (A): *2x8 Numerous floor joists exhibited powder post beetle activity. Powder post beetles are wood-destroying insects. I found numerous exit holes and frass (wood dust created from beetle activity clinging to the side of the wood) throughout the crawlspace. While some damage is modest and will not require repairs, At least 15 joists were found to be significantly damaged, requiring sistering or replacement. Also, I recommend having a pest inspector evaluate this further to determine if there is recent activity, and if so, what steps are needed to kill off the insects.*

- Floor Joists (A): 2x8 *Numerous floor joists exhibited powder post beetle activity. Powder post beetles are wood-destroying insects. I found numerous exit holes and frass (wood dust created from beetle activity clinging to the side of the wood) throughout the crawlspace. While some damage is modest and will not require repairs, At least 15 joists were found to be significantly damaged, requiring sistering or replacement. Also, I recommend having a pest inspector evaluate this further to determine if there is recent activity, and if*

so, what steps are needed to kill off the insects.

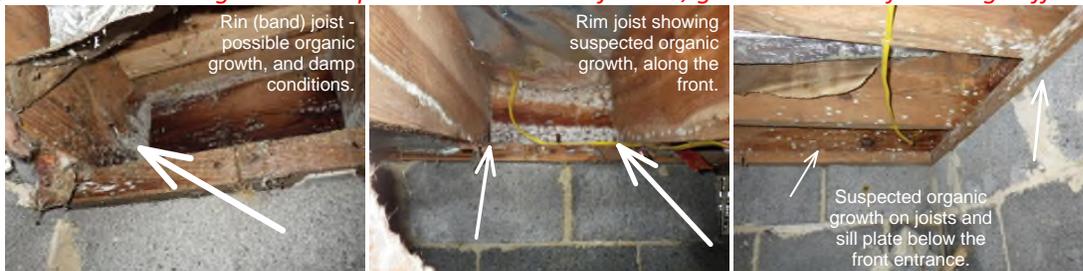
8. *Defective* Floor Joists (B): *2x8 Joists in the crawlspace area below the front entrance were covered in places with a spotty white substance which is suspected organic growth. Also, the rim joist (band joist) along the front towards the adjoining living unit exhibited similar conditions, with a white coating. This condition suggests that dampness is encouraging organic growth. While no damage was apparent in these locations, hidden damage could be occurring; regardless, the damp conditions need to be mitigated. Also, I recommend that you consider having a mold inspector evaluate this further, given the area of coverage affected.*

13. Floor Joists (B): 2x8 Joists in the crawlspace area below the front entrance were covered in places with a spotty white substance which is suspected organic growth. Also, the rim joist (band joist) along the front towards the adjoining living unit exhibited similar conditions, with a white coating. This condition suggests that dampness is encouraging organic growth. While no damage was apparent in these locations, hidden damage could be occurring; regardless, the damp conditions need to be mitigated. Also, I recommend that you consider having a mold inspector evaluate this further, given the area of coverage affected.

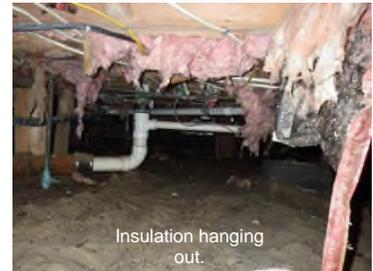
6. Defective Insulation: *Foil-faced fiberglass Insulation was loose, hanging or had fallen out in a number of places. Also, the use of foil faced insulation with the vapor barrier down can result in trapping moisture between the floor joists. I recommend removing the insulation at which time the wood can be further evaluated, and if insulation is replaced, that it be done with the vapor barrier up, not down.*

14. Main Crawl Space Insulation: *Foil-faced fiberglass insulation was loose, hanging or had fallen out in a number of places. Also, the use of foil faced insulation with the vapor barrier down can result in trapping moisture between the floor joists. I recommend removing the insulation at which time the wood can be further evaluated, and if insulation is replaced, that it be done with the vapor barrier up, not down.*

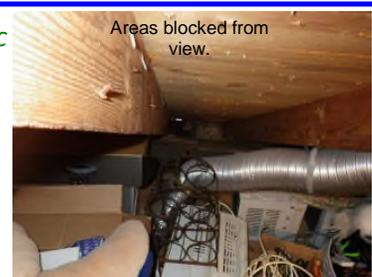
- 1. Means of Access: *Pull-down staircase in hallway*
- 2. *Advisory* Attic Conditions: *Obstructed with belongings* *Most areas of the attic were obstructed by the tenant's belongings and could not be directly inspected. So, hidden defects could exist.*

6. Main Attic Attic Conditions: *Obstructed with belongings Most areas of the attic were obstructed by the tenant's belongings and could not be directly inspected. So, hidden defects could exist.*

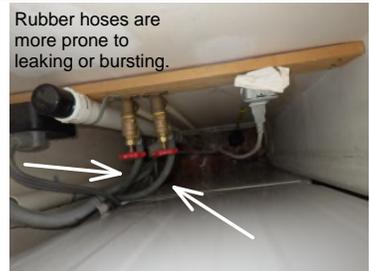
7. *Acceptable* Washer Hose Bib: *Gate valves*
8. *Not Inspected* Washer Drain: *Hidden Could not inspect*
9. *Advisory* Washer Supply Hoses: *Rubber Rubber washer supply hoses are more prone to leaks than the stainless steel ones. These hoses may be old and so I recommend replacing them with the more durable stainless steel braided ones as a precaution against water damage.*

8. Closet by entrance Laundry Room/Area Washer Supply Hoses: *Rubber Rubber washer supply hoses are more prone to leaks than the stainless steel ones. These hoses may be old and so I recommend replacing them with the more durable stainless steel braided ones as a precaution against water damage.*

Rubber hoses are more prone to leaking or bursting.

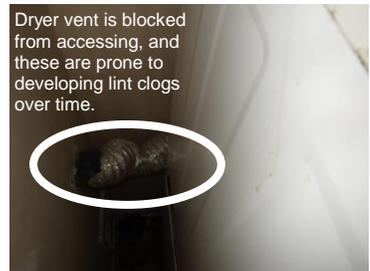
10. *Acceptable* Dryer: *Maytag*
11. *Advisory* Dryer Vent: *Mylar Since I cannot evaluate the inside of the dryer vent for lint accumulation, I recommend having the vent checked and cleaned before using the dryer, and periodically thereafter as part of a preventative maintenance program, since lint is flammable .*

9. Closet by entrance Laundry Room/Area Dryer Vent: *Mylar Since I cannot evaluate the inside of the dryer vent for lint accumulation, I recommend having the vent checked and cleaned before using the dryer, and periodically thereafter as part of a preventative maintenance program, since lint is flammable.*

Dryer vent is blocked from accessing, and these are prone to developing lint clogs over time.

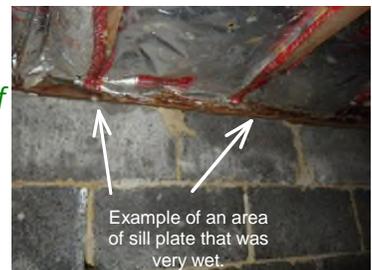
10. General Structural Comments: *Hidden components As in most homes, some structural components are hidden within walls and ceilings, and so they cannot be directly inspected.*
11. Differential Movement: *Uneven floors The floors exhibited out-of-level conditions, which I consider typical for older homes. Unless otherwise noted elsewhere in this report, I found no material structural defects to explain the conditions, which I attribute to the effects of long-term settlement and longer spans of floor joists.*
12. Sill Beam or Plate: *Wood Areas of the sill plate were very wet, a condition that encourages organic growth and rot. As noted elsewhere in this section, I recommend finding a way to mitigate the damp conditions to extend the life of the wood.*

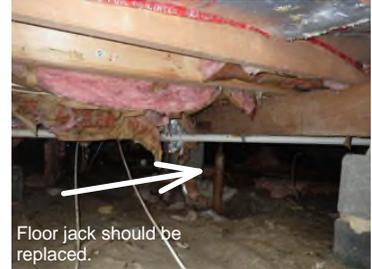
10. *Acceptable* Piers/Posts: *Block piers*
11. *Advisory* Piers/Posts: *Floor jacks A steel floor jack is substantially rusted and has approached the end of its expected service life. I recommend replacing it with a concrete block pier on a footing, which is a permanent replacement for a temporary solution.*

13. Piers/Posts: *Floor jacks A steel floor jack is substantially rusted and has approached the end of its expected service life. I recommend replacing it with a concrete block pier on a footing, which is a permanent replacement for a temporary solution.*
